The England Group LLC

Property Inspection Report

1342 Main St, Springville , UT 84633
Inspection prepared for: Utah Client
Date of Inspection: 5/2/2024 Time: 10 am
Age of Home: 2024 Size: 2260
Weather: Cold, sunny.

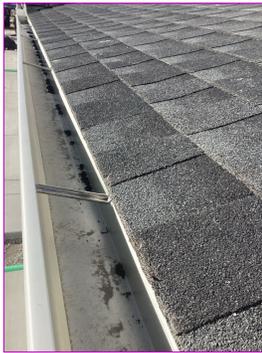
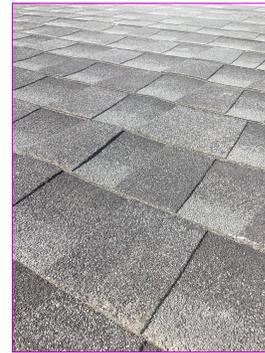
• Although this townhome is reported to be part of an HOA and the exterior structure, including the roof, is not the responsibility of the client, a minimal inspection of the roof was conducted. The roof was covered with dimensional fiberglass asphalt shingles, also called "architectural" or "laminated" shingles. Fiberglass shingles are composed of a fiberglass mat embedded in asphalt and covered with ceramic-coated mineral granules. Dimensional shingles are composed of multiple layers bonded together. Shingles with multiple layers bonded together are usually more durable than shingles composed of a single layer. Dimensional shingles usually have a 30-40 year warranty. The actual useful lifespan varies with shingle quality. Determining shingle quality or remaining shingle roof lifespan lies beyond the scope of the General Home Inspection.

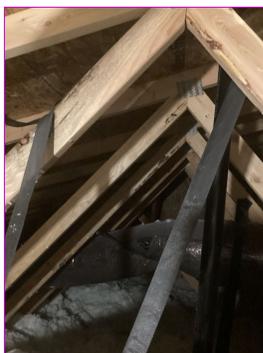
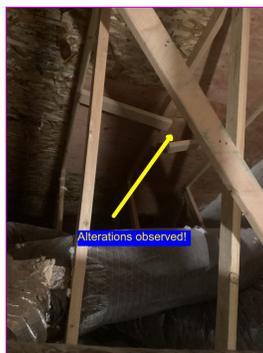
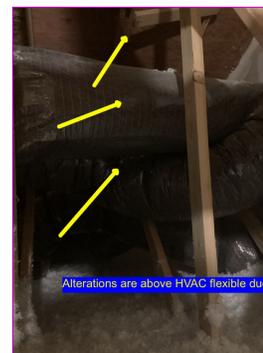
2. Truss Roof Structure

• Roof trusses that had been structurally altered were visible in the attic. Trusses must never be structurally altered without design, inspection and approval by a structural engineer. The Inspector recommends that you ask the seller for documentation showing that any alterations to the roof trusses were designed, inspected and approved by a structural engineer. If the seller cannot produce such documentation, the Inspector recommends that before the expiration of your Inspection Objection Deadline you have the roof trusses evaluated by a structural engineer.

Page 6 Item: 2	Truss Roof Structure	<ul style="list-style-type: none"> • Roof trusses that had been structurally altered were visible in the attic. Trusses must never be structurally altered without design, inspection and approval by a structural engineer. The Inspector recommends that you ask the seller for documentation showing that any alterations to the roof trusses were designed, inspected and approved by a structural engineer. If the seller cannot produce such documentation, the Inspector recommends that before the expiration of your Inspection Objection Deadline you have the roof trusses evaluated by a structural engineer.
Page 6 Item: 4	Thermal Insulation Depth	<ul style="list-style-type: none"> • Attic floor insulation depth averages 12 to 14 inches but several areas are low as 8 inches. To maximize savings on heating and cooling costs, insulation levels should comply with local energy codes.

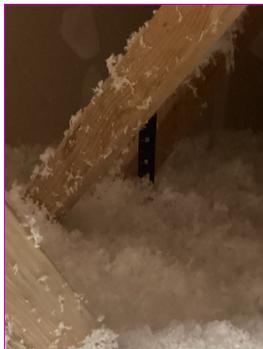
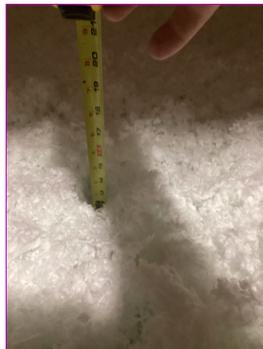
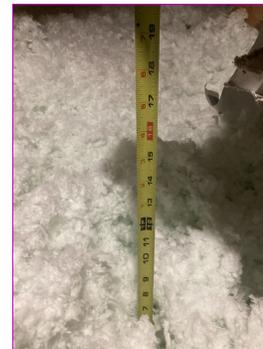
4. Thermal Insulation Depth

• Attic floor insulation depth averages 12 to 14 inches but several areas are low as 8 inches. To maximize savings on heating and cooling costs, insulation levels should comply with local energy codes.

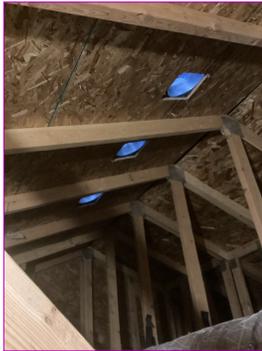
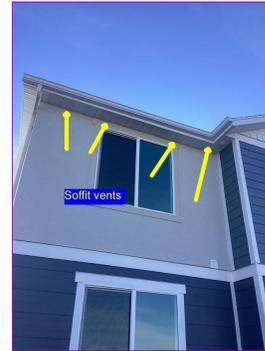
6. Attic Ventilation

- Soffit vents were installed as part of the roof structure ventilation system.
- Roof vents, also called turtle vents, were installed as part of the roof structure ventilation system.

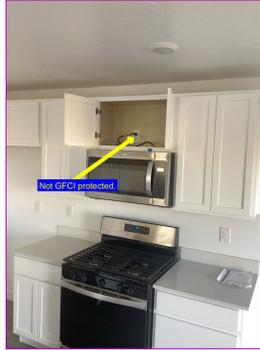
2. Microwave

Note that the plug for the microwave is not GFCI protected.

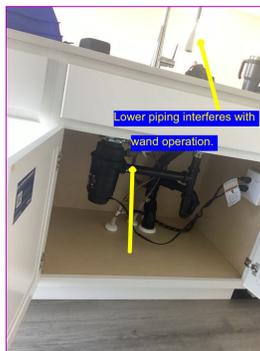
5. Sink

• The extension wand at the kitchen sink was inoperable due to lower piping in the way. The fix is easy but noted.

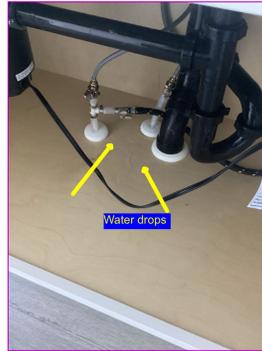
6. Dishwasher

- During operation the dishwasher supply pipe leaked water onto the cabinet floor. The valve was returned to a closed position to avoid damage. The Inspector recommends service by a qualified contractor or technician.
- The dishwasher operation appeared to not be supplying any water to the dishwasher inner racks. It also made an unusual noise indicating that it was not operating correctly. The Inspector recommends evaluation by a qualified plumbing contractor or technician.

Page 9 Item: 6	Dishwasher	<ul style="list-style-type: none"> • During operation the dishwasher supply pipe leaked water onto the cabinet floor. The valve was returned to a closed position to avoid damage. The Inspector recommends service by a qualified contractor or technician. • The dishwasher operation appeared to not be supplying any water to the dishwasher inner racks. It also made an unusual noise indicating that it was not operating correctly. The Inspector recommends evaluation by a qualified plumbing contractor or technician.
----------------	------------	---

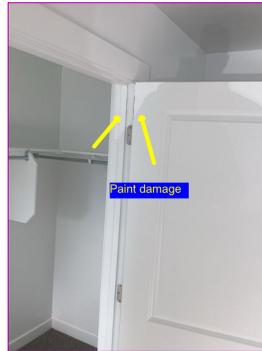
1. Closet Doors

- Closet doors in this bedroom were closed prior to the paint drying. Damage occurred at hinge.

Page 9 Item: 1	Closet Doors	• Closet doors in this bedroom were closed prior to the paint drying. Damage occurred at hinge.
----------------	--------------	---

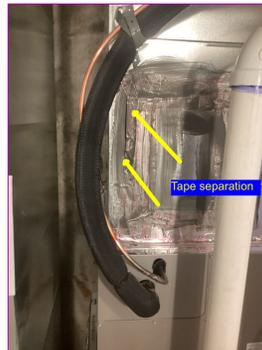
1. Furnace Exterior

- Poor sealant adhesion visible on the furnace cabinet exterior above the burn chamber may indicate further separation forthcoming. The furnace should be serviced by a qualified HVAC contractor.

Page 11 Item: 1	Furnace Exterior	• Poor sealant adhesion visible on the furnace cabinet exterior above the burn chamber may indicate further separation forthcoming. The furnace should be serviced by a qualified HVAC contractor.
-----------------	------------------	--

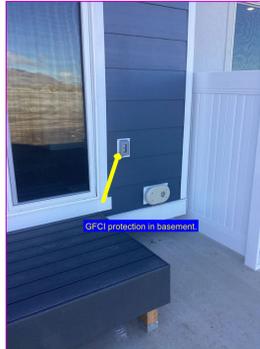
2. GFCI/AFCI Receptacles

Let it be noted that the receptacle on the back porch is connected to the GFCI outlet that is near the electrical panel in the basement .

The inspector was unable to find the GFCI that controls the front porch outlet. It is recommended to ask the seller for details on that particular receptacle.

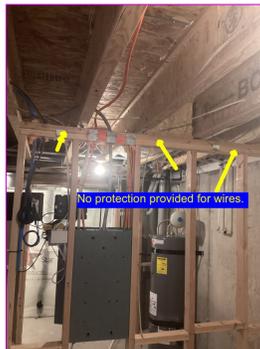
3. Misc. Wiring Deficiencies

- Wiring in the basement was not protected from damage. The Inspector recommends that any such unprotected wiring be corrected by a qualified electrical contractor to help ensure that safe conditions exist.

Page 16 Item: 3	Misc. Wiring Deficiencies	• Wiring in the basement was not protected from damage. The Inspector recommends that any such unprotected wiring be corrected by a qualified electrical contractor to help ensure that safe conditions exist.
-----------------	---------------------------	--

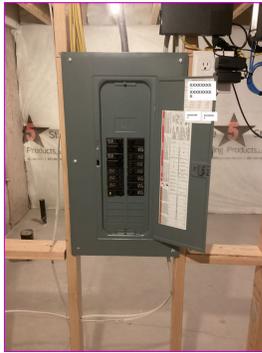
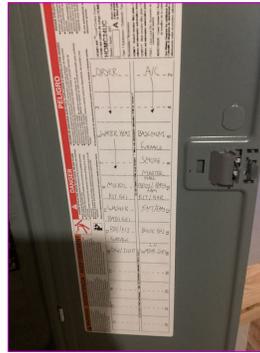
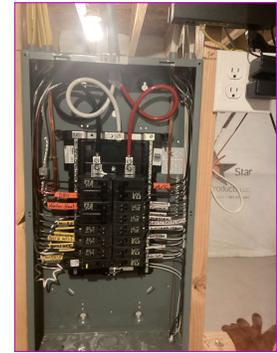
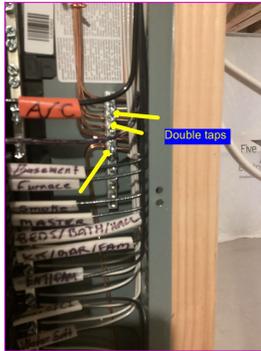
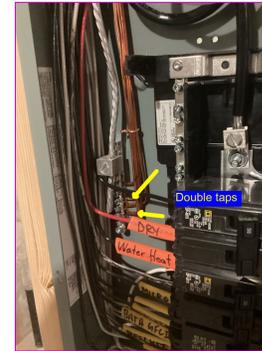
2. Wiring Defects

- One or more grounding wires in the service panel were possibly improperly terminated through double tapping. Although some panel manufacturers allowed this, it is a better practice to have single taps instead of double. This condition should be corrected by a qualified electrical contractor.

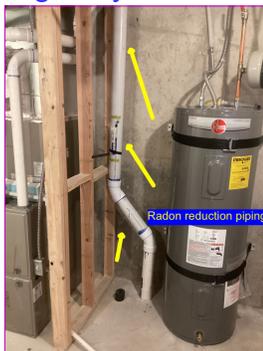
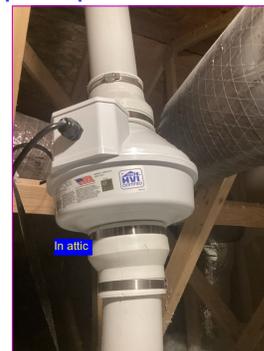
1. Radon

- The home is located in an area known to have radon and has a radon reduction system installed. The radon ventilation fan is located in the attic.

It is advised to regularly check the radon reduction system for proper operation.

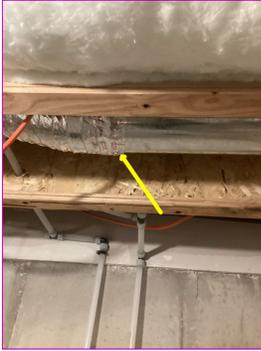
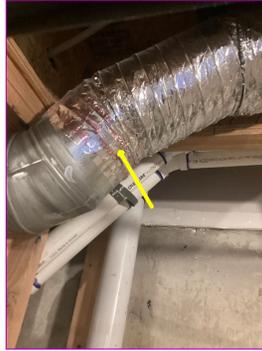
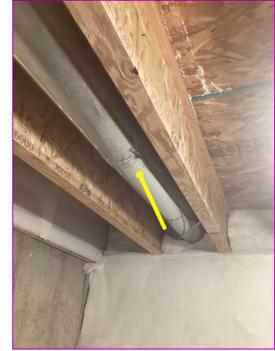
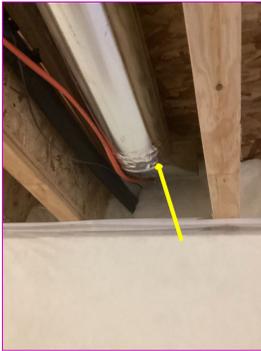
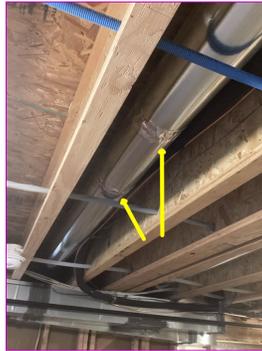
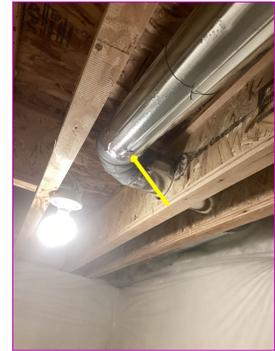
1. Supply Air Ducts

- Many of the air supply ducts in the basement and also attic were not sealed with mastic. The supply and return air ducts should be sealed with mastic to improve the HVAC system efficiency. Sealing tape is known to have a short life of just a few years.

Page 19 Item: 1	Supply Air Ducts	• Many of the air supply ducts in the basement and also attic were not sealed with mastic. The supply and return air ducts should be sealed with mastic to improve the HVAC system efficiency. Sealing tape is known to have a short life of just a few years.
-----------------	------------------	--
