The England Group LLC

Property Inspection Report

1342 Main St, Springville , UT 84633
Inspection prepared for: Utah Client
Date of Inspection: 5/2/2024 Time: 10 am
Age of Home: 2024 Size: 2260
Weather: Cold, sunny.

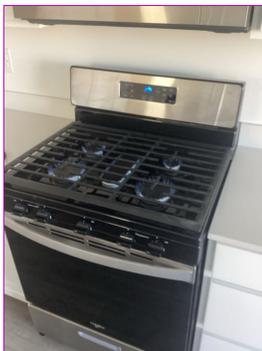
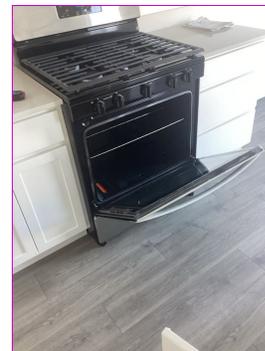
- The range was gas-fired. Inspection of gas ranges is limited to basic functions, such as testing of the range-top burners, and bake/broil features of the oven. The broil burner is at oven bottom and it is therefore assumed that the bottom drawer is used for the broiler.

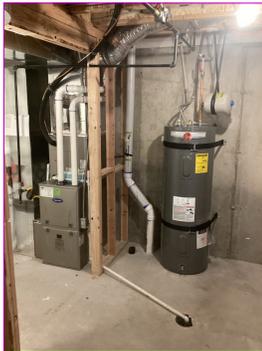
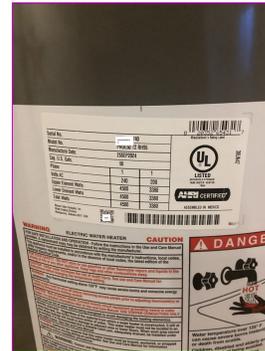
- The photo shows the data plate of the water heater.
- This water heater model number was PROE50T2RH95.
- The date of manufacture for this water heater appeared to be February 2021.
- The water heater was manufactured by Rheem.
- Water heater capacity was 50 gallons.

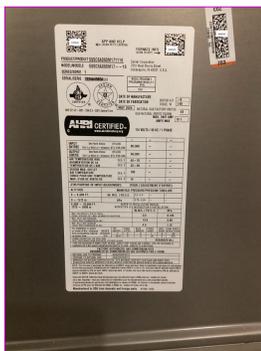
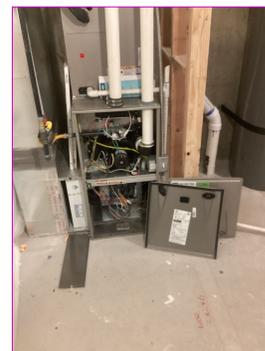
- The photo shows the information marked on the furnace label or data plate.
- This furnace was manufactured by Carrier.
- The date of furnace manufacture appeared to be January 2024.
- The model number of this furnace was 59SC6A060M17 — 16.

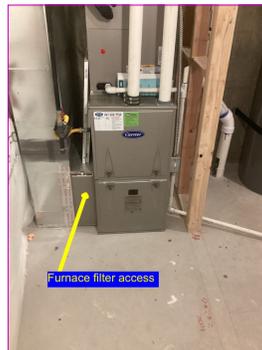
- Increased resistance resulting in the filter being sucked into the blower. This condition can be a potential fire hazard.
 - Frost build-up on air-conditioner evaporator coils, resulting in reduced cooling efficiency and possible damage.

- Reduced air flow through the home.

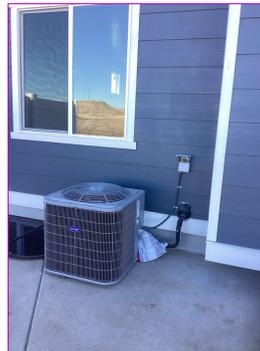
- The air conditioning system was a split system in which the cabinet housing the compressor, cooling fan and condensing coils was located physically apart from the evaporator coils. As is typical with split systems, the compressor/condenser cabinet was located at the home's exterior so that the heat collected inside the home could be released to the outside air. Evaporator coils designed to collect heat from the home interior were located inside a duct at the furnace.

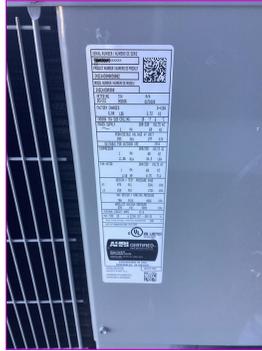
- Information from the air-conditioner label/data plate is shown in the photo.
- The air-conditioner date of manufacture appeared to be November 2023. The Serial Number was listed as xx. The Model Number was listed as 24SCA438N388.

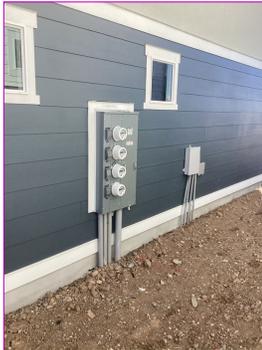
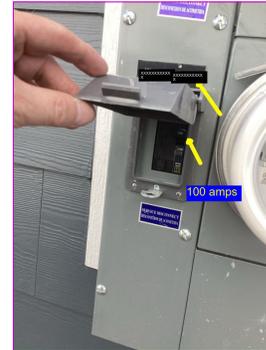
- The electric meter was located at the right side of the home.
